**MARITIME TRANSPORTATION RESEARCH AND EDUCATION CENTER
TIER 1 UNIVERSITY TRANSPORTATION CENTER
U.S. DEPARTMENT OF TRANSPORTATION**

**Rapid Assessment of Internal Erosion Damage and Erodibility in Levees
July 2020 – December 2023**

**FINAL RESEARCH REPORT
Prepared for:
Maritime Transportation Research and Education Center**

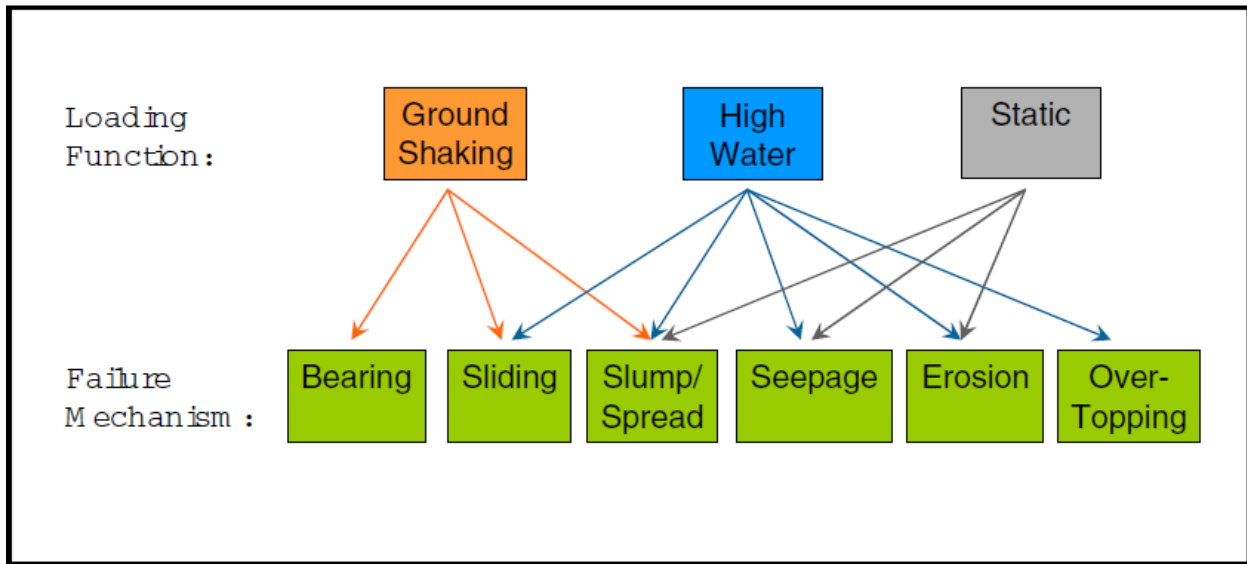
Figure 1 Relationship between loading type and failure mechanisms (Moss & Eller, 2007)

Moss and Eller (2007) propose a classification of levee failure mechanisms based on loading types, including seismic loading, hydraulic loading during flooding, and loading under static conditions. These loading types lead to bearing, sliding, slumping and spreading, seepage, erosion, and overtopping failure mechanisms (Figure 1). Erosion of soil, whether from internal erosion or overtopping erosion, is the most common cause of levee and embankment dam failures (Bonelli, 2013). Seepage through levees can lead to internal erosion and piping, which may ultimately progress into levee failure. In a review of earthen dam failures, Richards and Reddy (2007) classified piping failures into four categories: foundation-related piping failures, conduit and internal erosion piping failures, suffusion piping failures, and piping failures due to biological activity. The review found that thirty-one percent of piping failures were due to backward erosion piping (BEP), with an additional fifty percent due to internal erosion and piping along conduits and structures. However, determining the type of piping failure responsible is often not possible

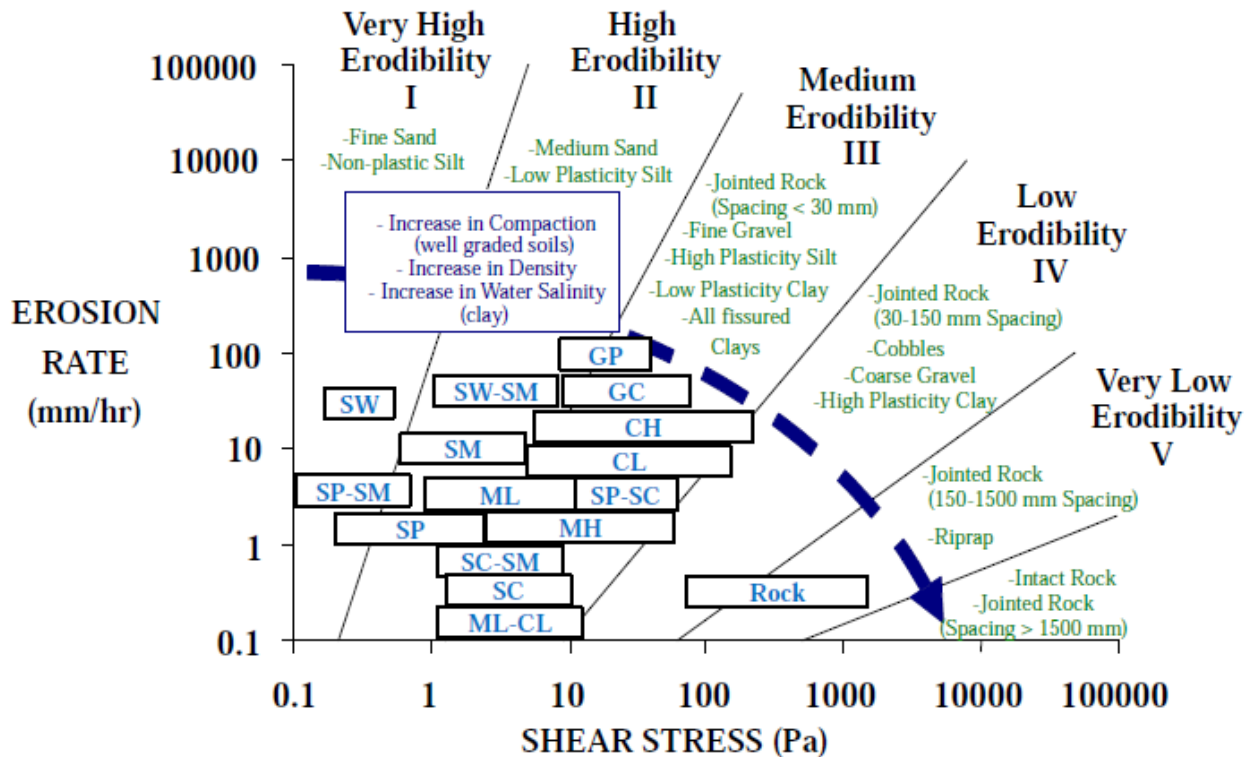
Figure 11 Erodibility Category Charts of Shear Stress (Pa) versus Erosion Rate (mm/hr) with USCS soil types (National Academies of Sciences, 2019)

Geophysical methods have also been used for estimation of surface soil erodibility (e.g., bridge scouring and levee overtopping). Fundamentally, the erodibility of a material can be represented by the relationship between the erosion rate (\dot{z}) in depth/time and the shear stress (τ) at the particle interface (National Academies of Sciences, 2019). Briaud (2008) introduced an erodibility categories classification system in the form of erosion rate versus velocity or erosion rate versus shear stress. This system is primarily based on extensive Erosion Function Apparatus (EFA) testing on a wide range of soil types. The erodibility category of a material is determined by plotting the erosion function of the material on the erosion category chart. Later work added USCS soil types to the erosion category chart (Figure 11). The width of each USCS soil type represents the zone that 90 percent of samples tested, for a given soil type, using EFA plotted on the erosion category chart (National Academies of Sciences (NAS), 2019). Although the erosion categories provide insight into the erodibility of a material, the erosion category is not adequate for design purposes (NAS, 2019).

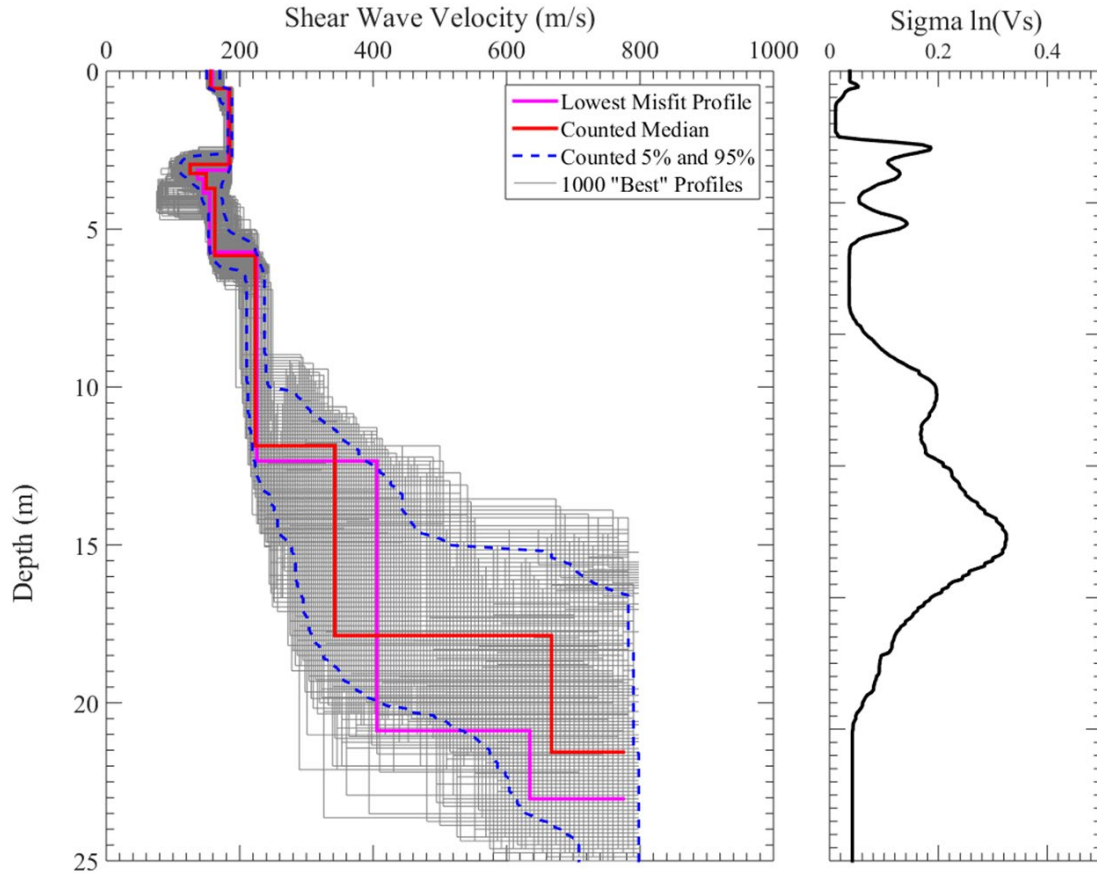
Figure 19 The 1000 lowest misfit profiles from the inversion process and standard deviation (blue) for MASW Line A Setup 3. The counted median shown in red is used as the 1-D V_s profile for each MASW setup

Dinver provides a graphical user interface for the inversion of surface wave data to estimate the 1-D Vs profile that resulted in the experimental dispersion curve. In dinver, multiple parameters are input to constrain the inversion, including ranges of Vs, Vp, layer thicknesses, and Poisson's ratio. A joint inversion of the MASW data and the frequency of the HVSR peaks was performed in Geopsy with weighting factors of 0.8 and 0.2, respectively. The joint inversion of MASW data and the HVSR peaks allowed for greater constraint of the inversions at depth, as there is limited low frequency content when using a sledgehammer source. A minimum of 100,000 models were searched using the neighborhood algorithm in Geopsy for the dispersion curve of each MASW setup. In the inversion process, Vs models are searched to minimize the misfit between the theoretical dispersion curve (i.e., the dispersion curve resulting from a Vs model) and the experimental dispersion curve. Multiple parameterizations (e.g., layer thickness, number of layers, and layer velocity ranges) were explored to fit the experimental dispersion data. A parameterization of 9 to 11 layers with increasing layer thickness with depth and Vs ranging from 75 m/s to 1000 m/s was determined to best fit the experimental dispersion data. Water level measurements at the B-23 piezometer located in the internal erosion area were used to guide the Vp parameterization. The quality of the fit between the theoretical and experimental dispersion curves was judged on both the value of the misfit parameter and by visual comparison with the experimental dispersion curve. Visual comparison between the theoretical and experimental dispersion curves is necessary as the misfit parameter is not a physically meaningful parameter, and low values do not directly correlate to a high quality fit (Griffiths et al., 2016; Rahimi et al., 2018). This comparison was made on the level of dispersion curves and the 1-D Vs profiles resulting from the inversion process. For example, profiles of Vs versus pseudo depth (approximated as wavelength/2 of the experimental dispersion data) were plotted to ensure that any low velocity zones (LVZ) in the resulting 1-D Vs profiles correlated to velocity inversions in the experimental dispersion curves. The 1-D Vs profile of each MASW setup was taken as the median Vs profile of the 1000 lowest misfit profiles (Figure 19). It can be observed that there is more uncertainty in the Vs profiles with depth; this is likely due to a loss resolution with depth and the limited low frequency content of the sledgehammer source. The individual 1-D Vs profiles from each MASW setup were combined into pseudo 2-D Vs cross-sections. The pseudo 2-D Vs cross-sections for each MASW line were produced using triangulation with linear interpolation between the 1-D Vs profiles in the Surfer 14 program from Golden Software.

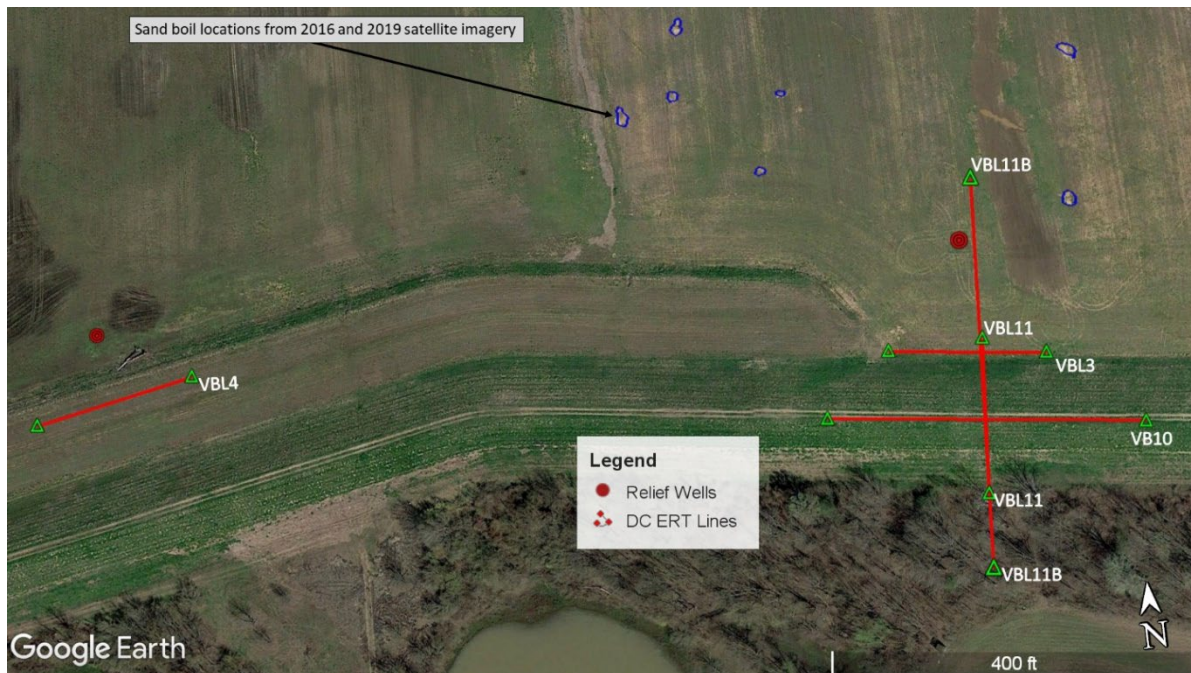
Figure 21 Control area DC ERT lines

landside line, VBL3 (Figure 21). VBL11B was located as an extension of VBL11 and for observation of temporal changes in the control area. An additional longitudinal landside DC ERT line (VBL4) was collected approximately 210 m west of the control area on the outside edge of the existing seepage berm, as measured along the levee crest.

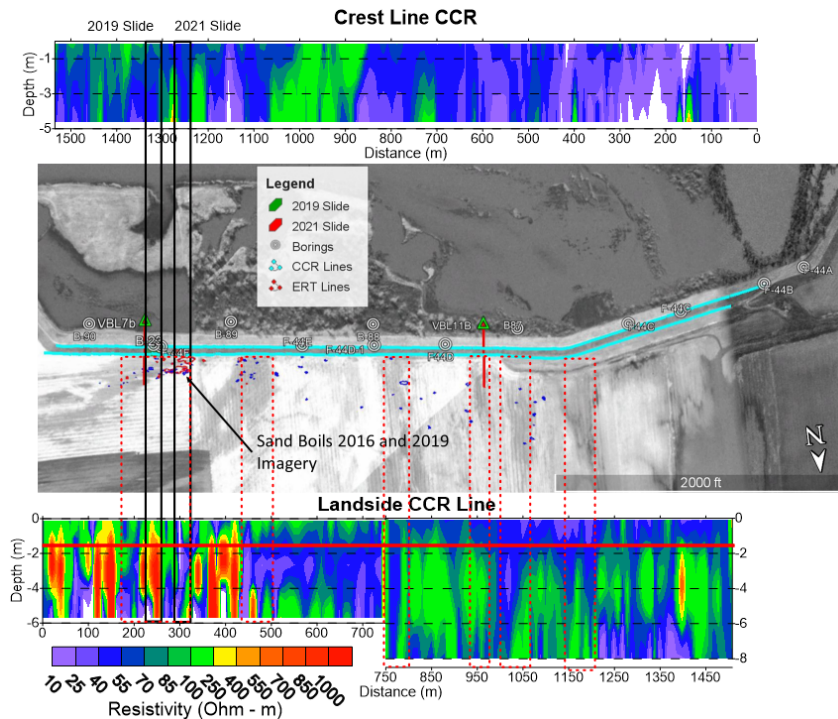
Figure 32 Crest and landside CCR lines aligned with USGS aerial imagery from March 2001

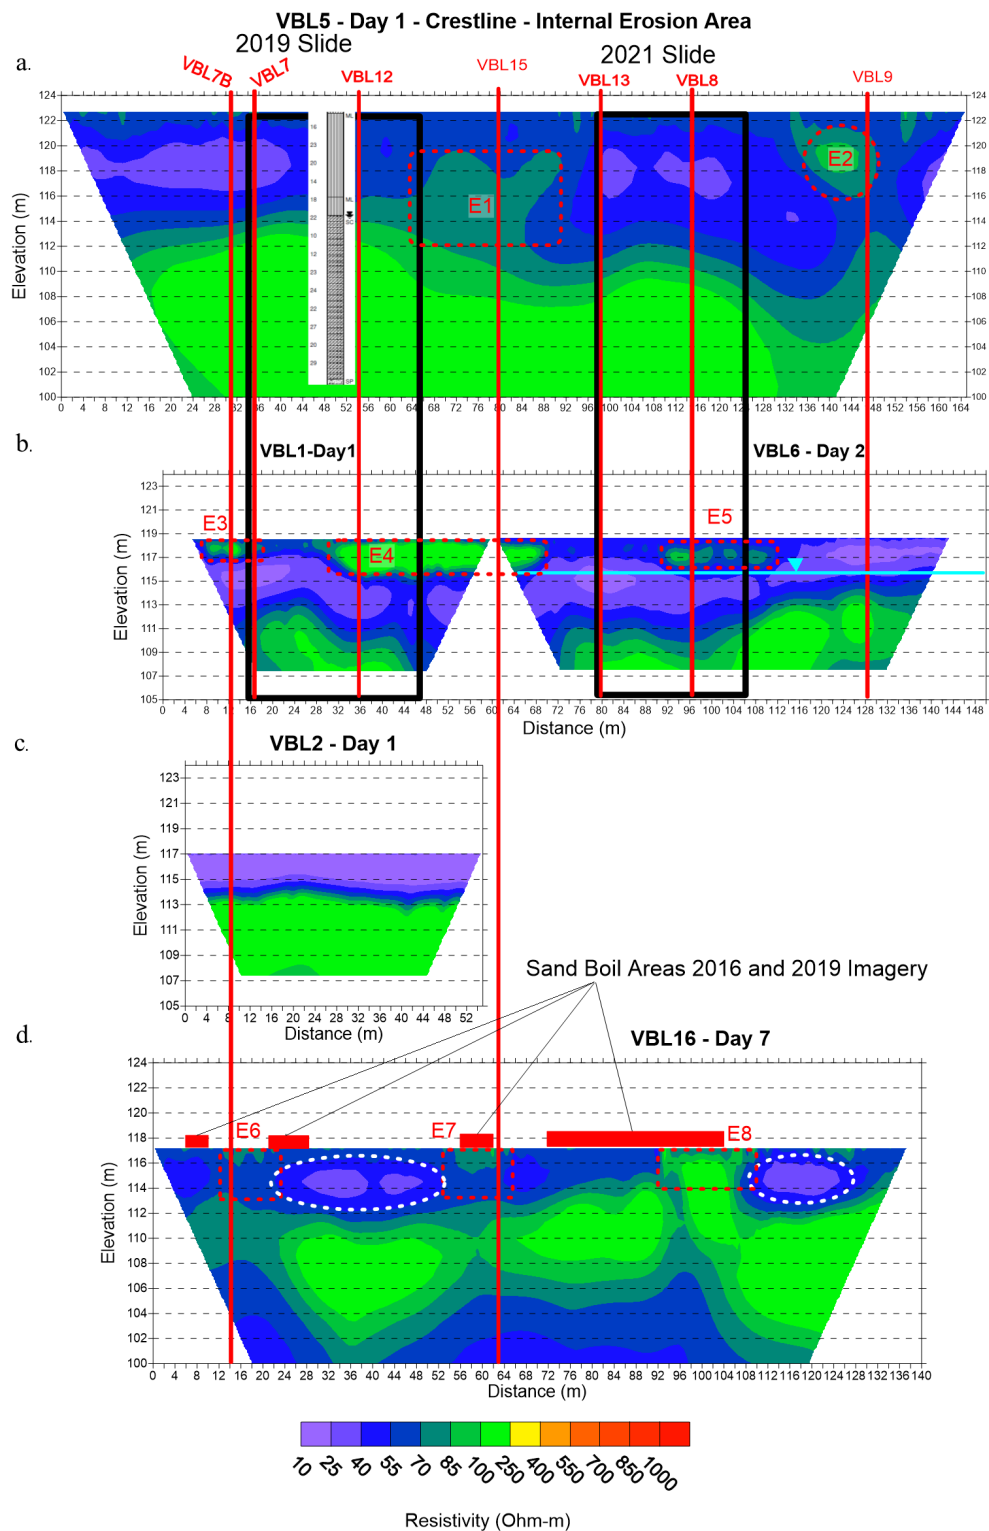
Figure 34 Internal erosion area longitudinal DC ERT lines, a)VBL5, b)VBL1/VBL6, c)VBL2, and d) VBL16

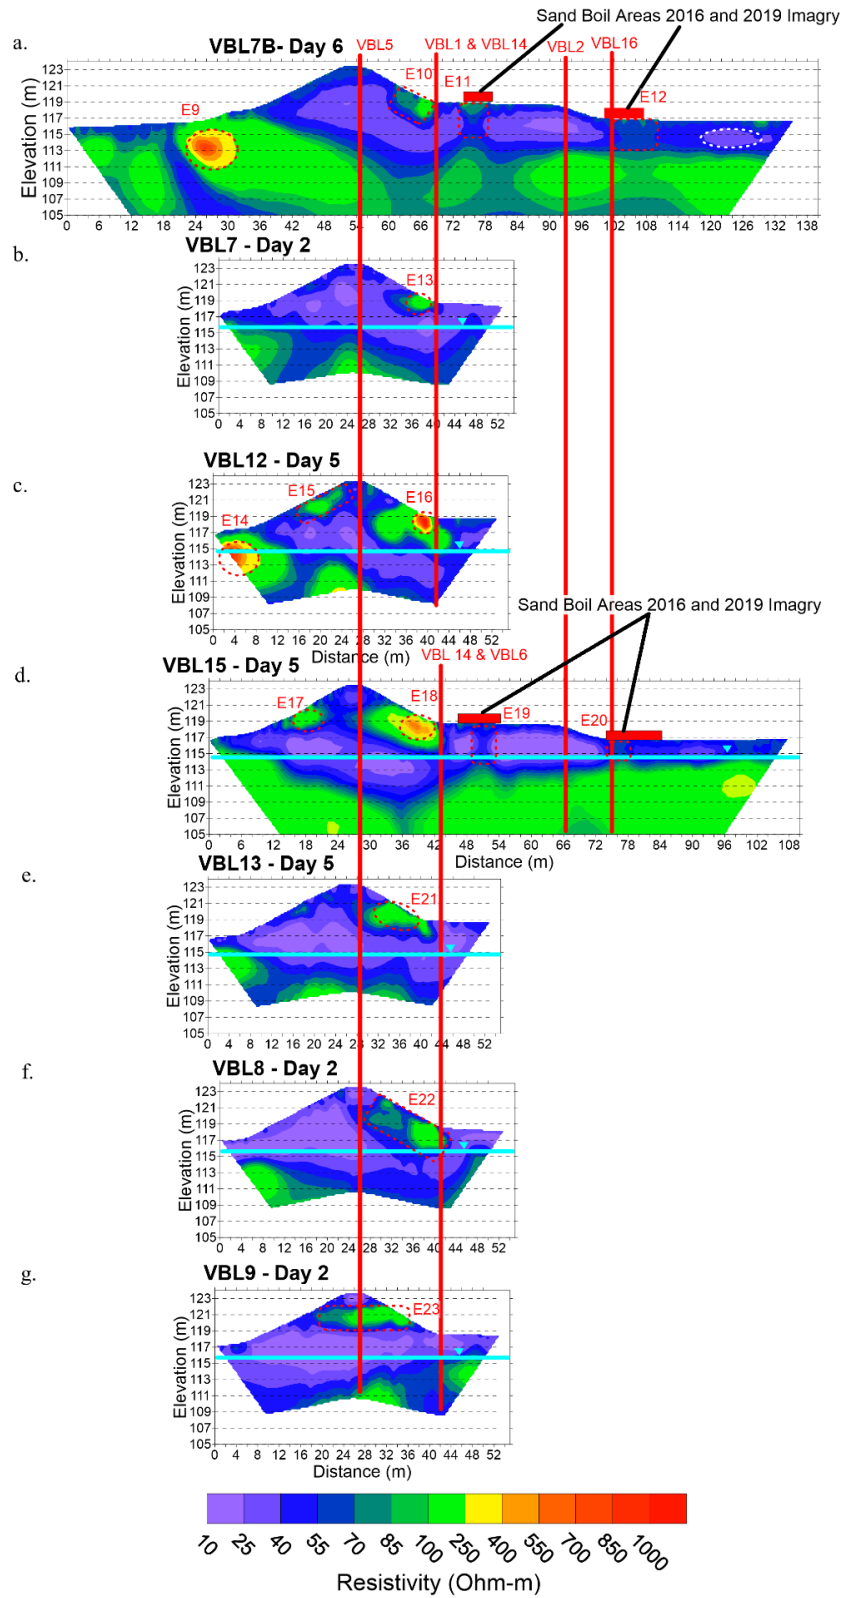
Figure 35 Internal Erosion area transverse DC ERT lines, a) VBL7B, b) VBL7, c) VBL12, d) VBL15, e) VBL13, f) VBL8, g) VBL9

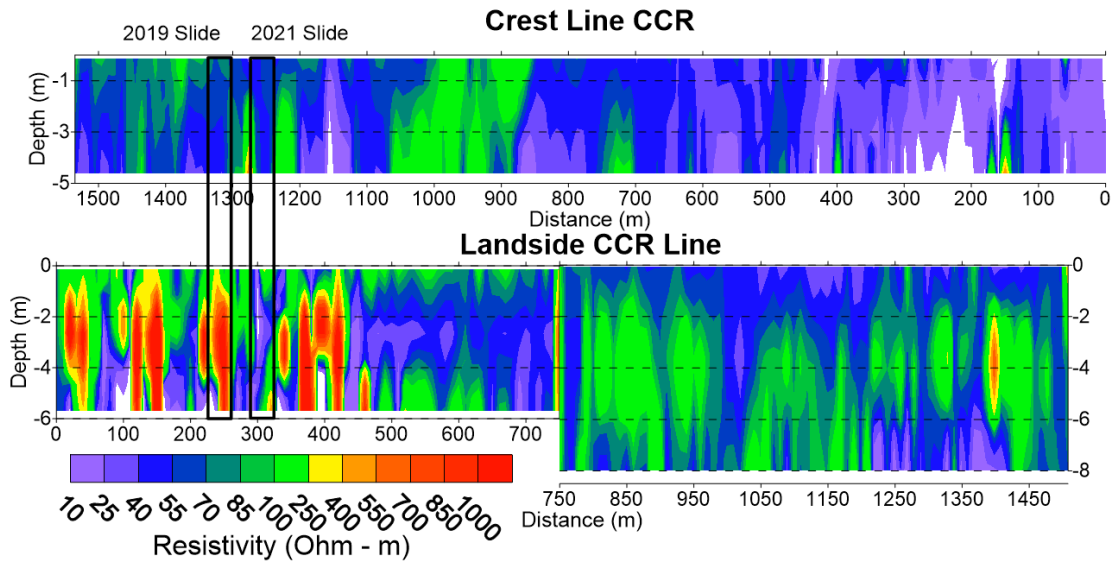
Appendix A-1 Crest and landside CCR lines

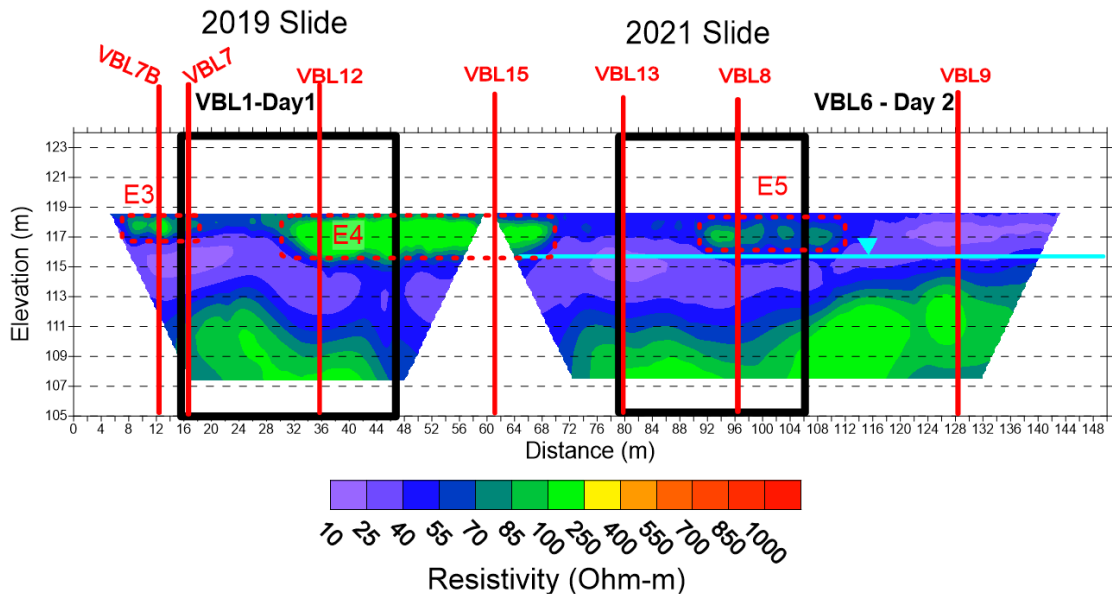
Appendix A-2 Internal erosion area longitudinal landside DC ERT lines VBL1 and VBL6

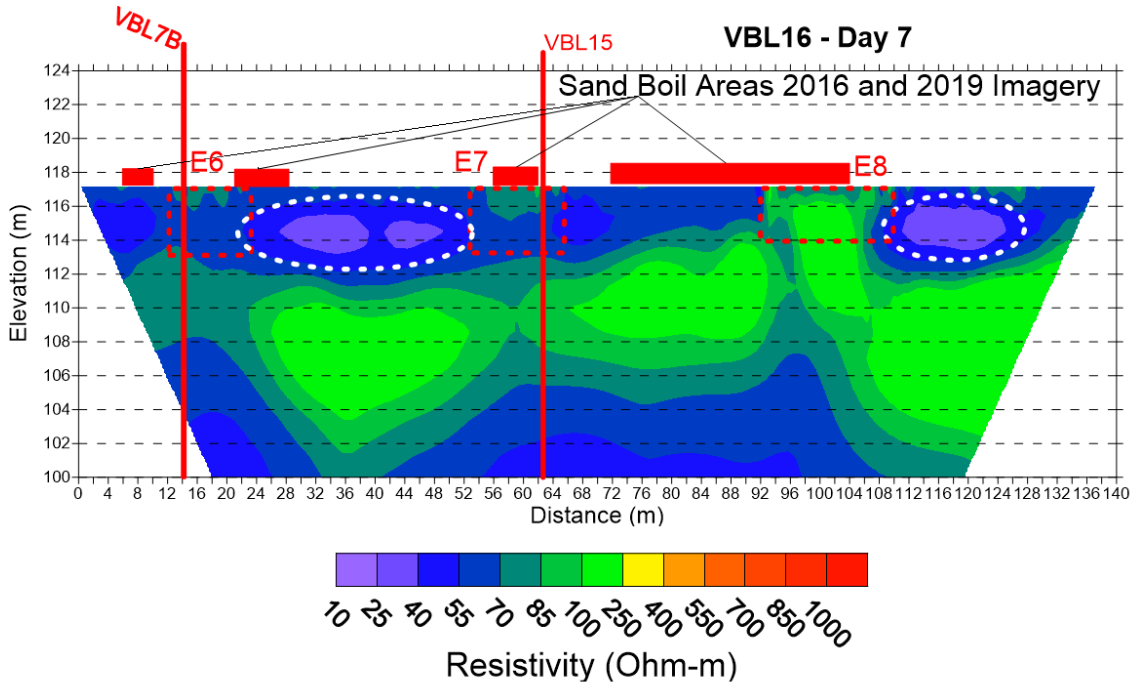
Appendix A-17 Internal erosion area longitudinal landside DC ERT line VBL16

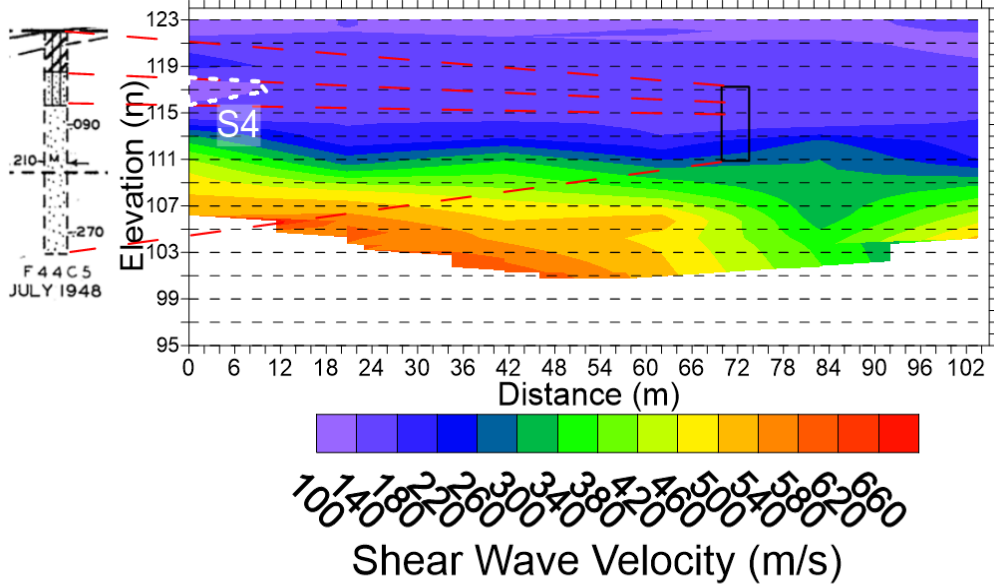
Appendix A-22 Control area crest MASW line D
